## SEEPAGE-INDUCED FAILURE AND DOWNSTREAM IMPACT ASSESSMENT OF GORONYO DAM, NIGERIA

**Abstract:** Seepage and slope instability are major causes of embankment dam failure, often leading to loss of life, property damage, and socio-economic disruption. The Goronyo Dam, commissioned in 1984 on River Rima in Sokoto State, Nigeria, has a storage capacity of  $942 \times 10^6 \text{ m}^3$  and serves over 80,000 ha of irrigated land. However, persistent water loss has raised concerns about seepage-induced deterioration and structural safety. This study investigated seepage behaviour, identified possible failure mechanisms, and assessed potential downstream impacts. Soil samples from failed and unfailed embankment sections were tested for particle size distribution, Atterberg limits, compaction, permeability, and shear strength. Results show predominantly fine-grained soils classified as low- to medium-plasticity clay (CL). The average liquid limit, plastic limit, and plasticity index were 31.8%, 19.5%, and 12.3%, respectively. Failed sections exhibited higher optimum moisture content (22.81%) and lower maximum dry density ( $1.67 \text{ Mg/m}^3$ ) compared to unfailed sections (17.05% a

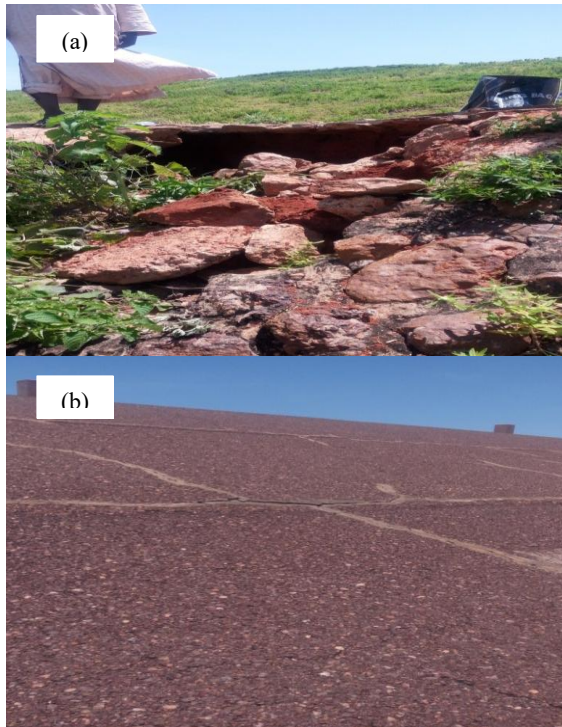
The failed sections of the dam refer to portions of the embankment that have already experienced structural failure, as illustrated in Plate 1. Soil Samples 1, 3, and 5 were obtained from these failed sections. In contrast, the unfailed sections comprise portions of the dam that remain structurally stable and undamaged. Soil Samples 2, 4, and 6 were collected from these intact sections, as shown in Plate 1.

**Plate 1:** (a) Failed section at the downstream toe (b) Unfailed section at the upstream of the dam.

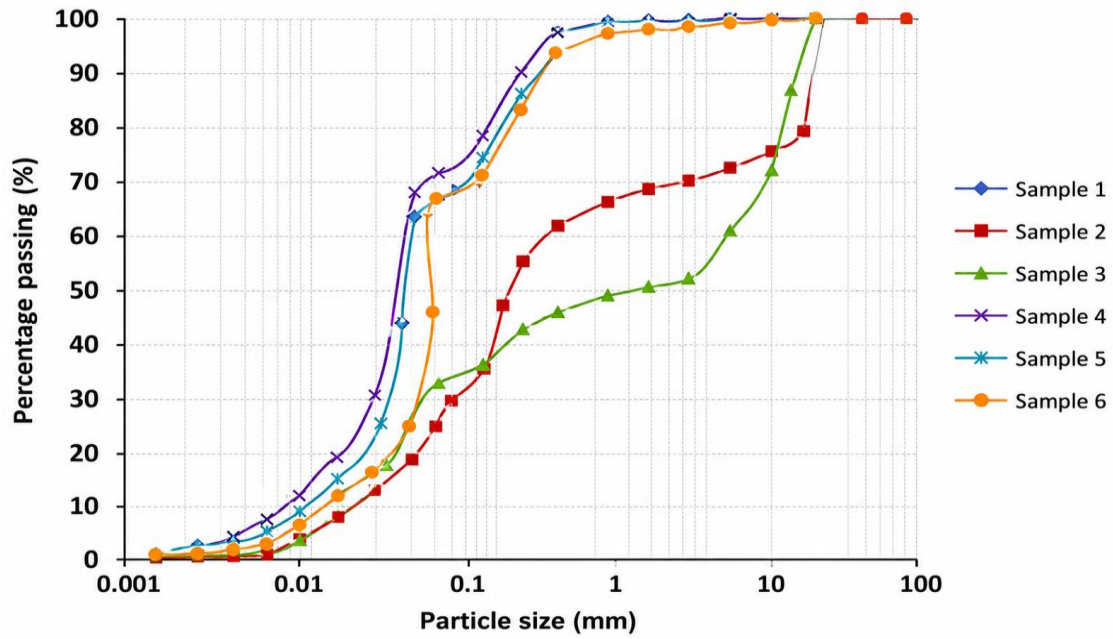
The results obtained from the laboratory tests conducted on the soil samples from the failed and unfailed sections of the Goronyo dam are presented in this section. The particle size distribution curves of the soil samples from the failed and unfailed sections are presented in Figure 2 and the summary of the properties of these soil samples are shown in Table 2. The particle size distribution results presented in Figure 2 indicate that the embankment materials are predominantly fine-grained soils, with fines content ranging from approximately 32 to 69%. Failed sections exhibit an average fines content of 52.92%, while unfailed sections show a comparable value of 53.61%. This similarity suggests that grain size distribution alone is not the primary cause of failure. However, the relatively high fines content implies reduced permeability and may increase susceptibility to internal erosion (piping) under seepage gradients.

Figure 2: Particle size distribution curves of the soil (samples 1, 3 & 5 – failed section, while 2, 4 & 6 – unfailed section)

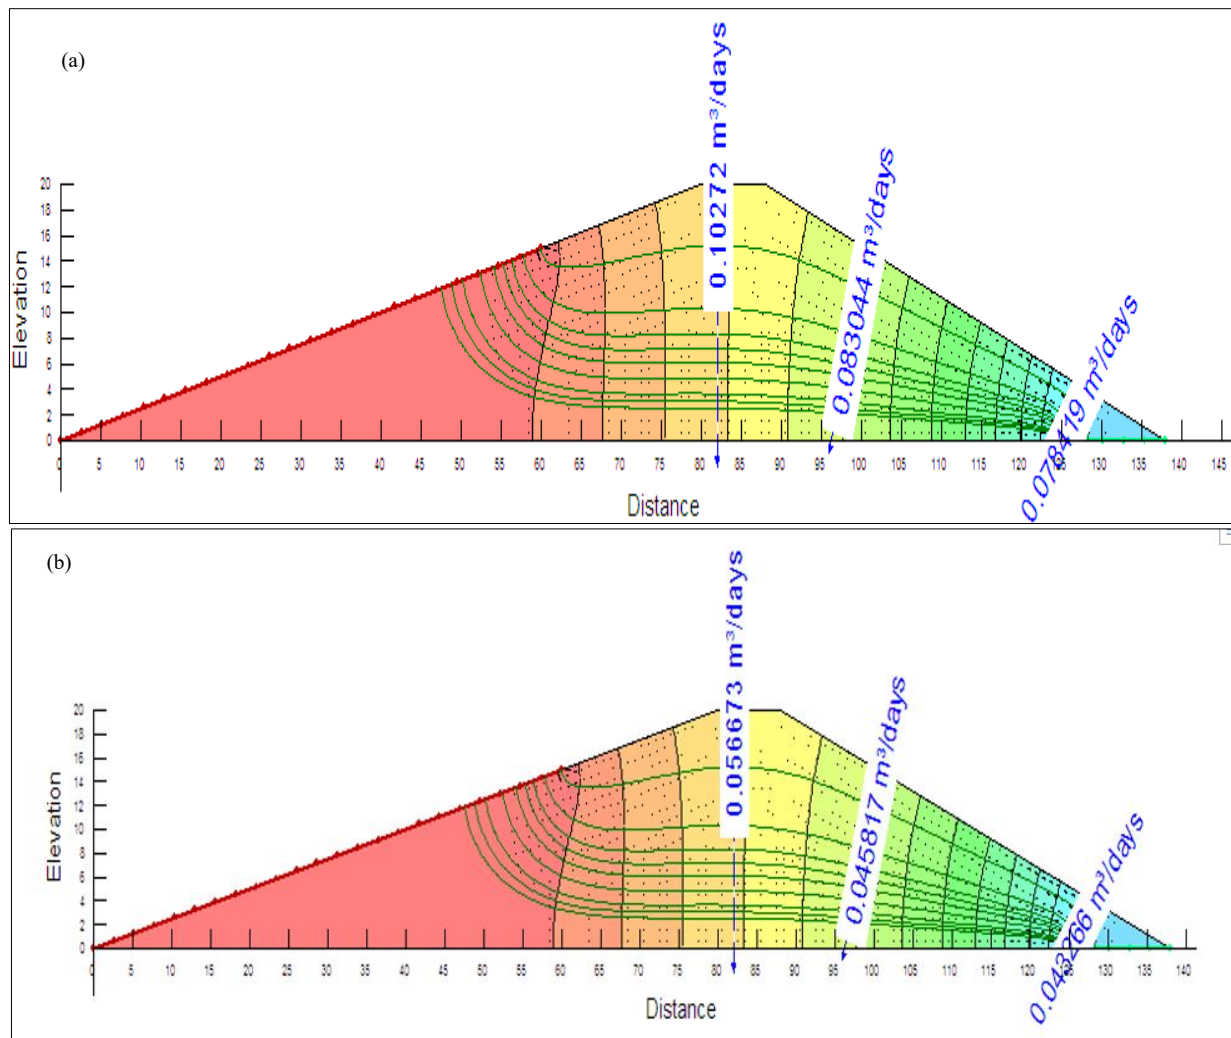
The computed seepage discharges obtained through seepage analysis using SEEP/W (GeoSlope, 2007) is presented in Figure 3.

From this Figure, the estimated seepage discharges ranges from 2.87–3.29 m<sup>3</sup>/day/km for failed sections and 1.35–3.15 m<sup>3</sup>/day/km for unfailed sections. The summary of the seepages discharges for the failed and unfailed sections was presented in Table 3. These values were significantly lower than the observed field seepage (73.04 m<sup>3</sup>/day/km). Thus, a noticeable discrepancy was observed between the seepage quantities predicted by the numerical model and those measured in the field. Such differences are common in embankment dam studies because numerical seepage models are developed under idealized assumptions, including homogeneous material properties, continuous soil layers, and steady-state hydraulic conditions. In contrast, actual field conditions are often heterogeneous and influenced by several physical and environmental factors that are difficult to incorporate fully into numerical simulations. These findings are in agreement with that of Jia et al. (2022) and Tan, et al. (2017). Moreover, numerical modelling

results are approximation results rather than exact predictions. The excessive seepage suggests the development of internal erosion (piping), progressive enlargement of

flow channels and loss of fines through seepage flow (Figure 4). Therefore, seepage is identified as the dominant failure mechanism (Al-Janabi et al., 2025; Foster, et al., 2000).

Figure 3: Seepage model and quantities (a) Failed section (b) Unfailed section

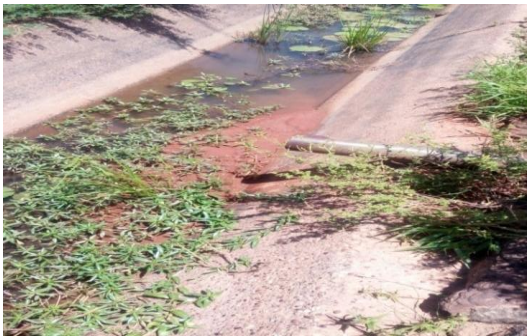
**Figure 4:** Seepage flow containing eroded material from the dam

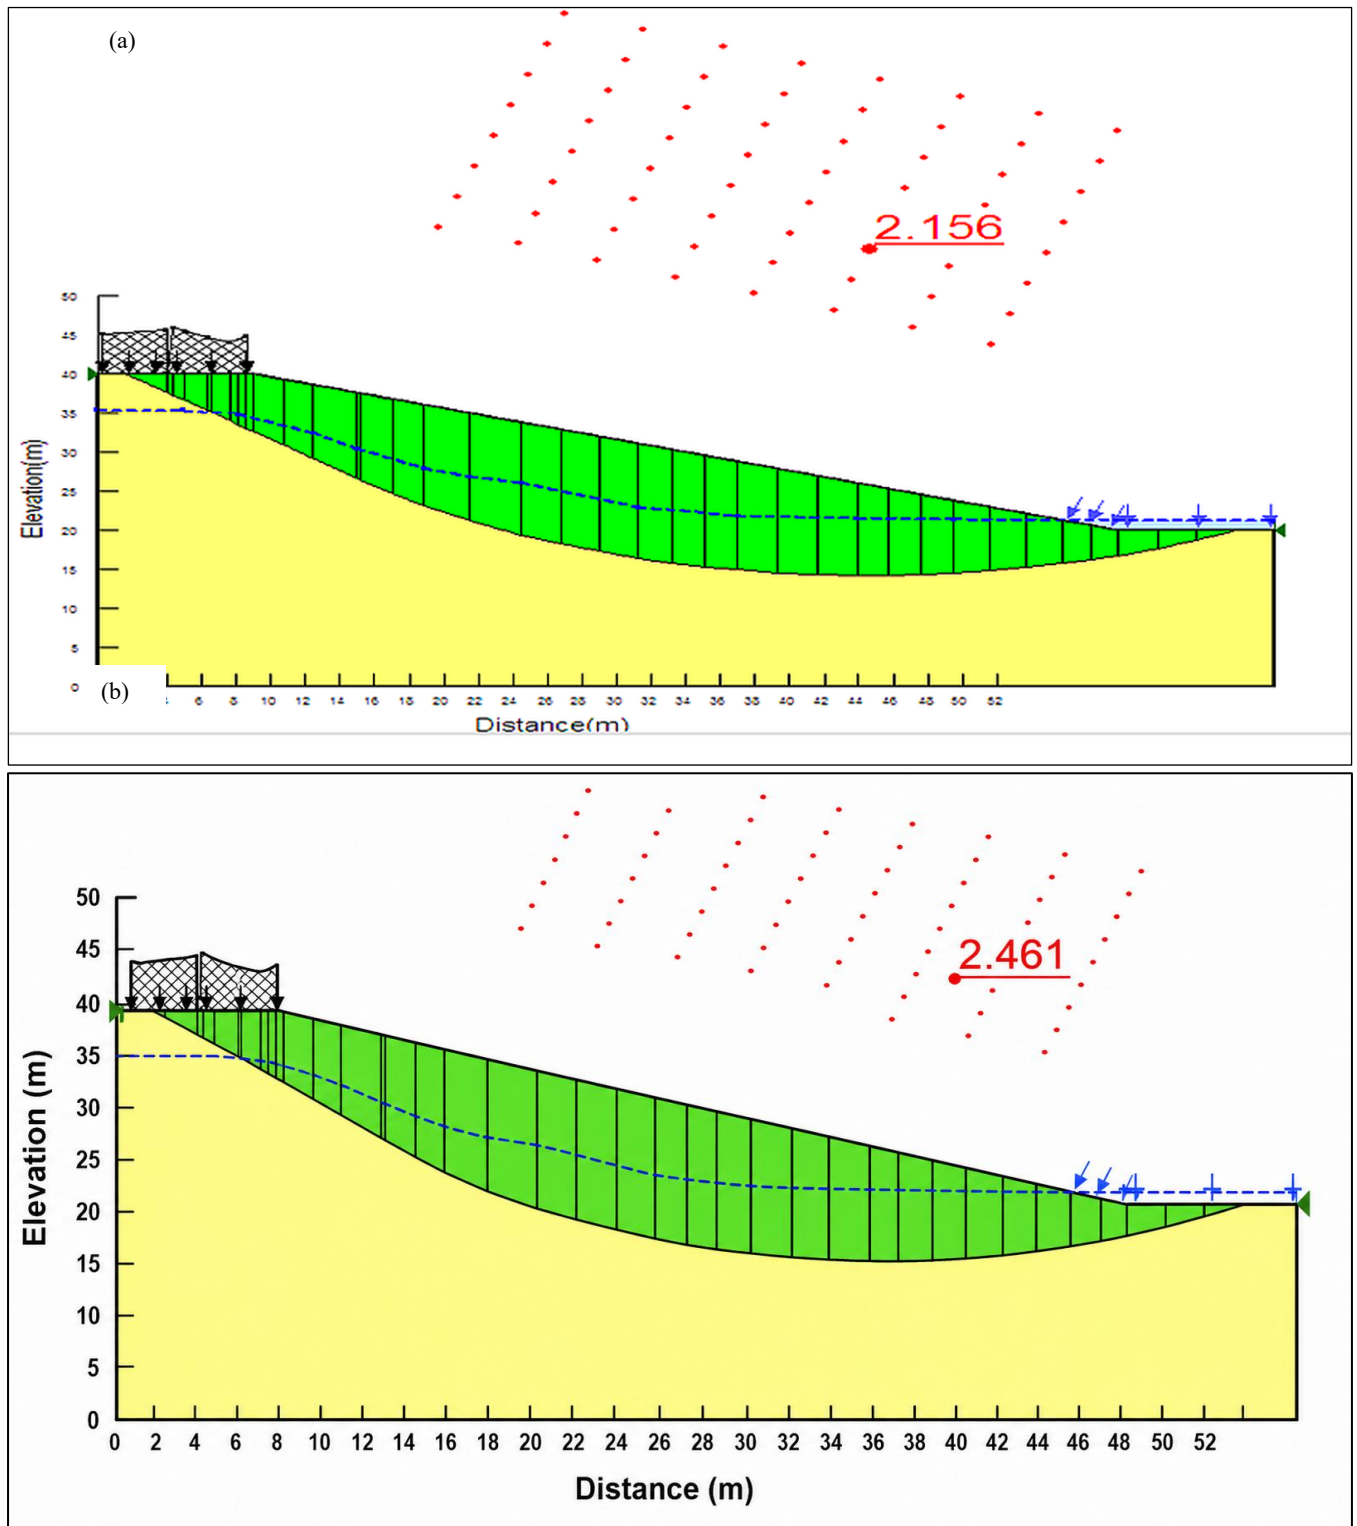
For the upstream slope, the FoS varies between 2.25 – 2.79 for the failed sections and 2.28 - 3.78 for the unfailed sections of the upstream slope of the dam.

The average FoS for the failed and unfailed sections of the upstream slope are 2.50 and 3.08, respectively. The computed factors of safety (FOS) for the investigated sections were all greater than 1.5. According to USACE EM 1110-2-1902, a minimum FOS of 1.5 is recommended for the long-term stability of the downstream slope of earth and rock-fill dams under steady-seepage conditions.

Figure 5: Sample of FoS for the upstream slope (a) the failed section, (b) the unfailed section

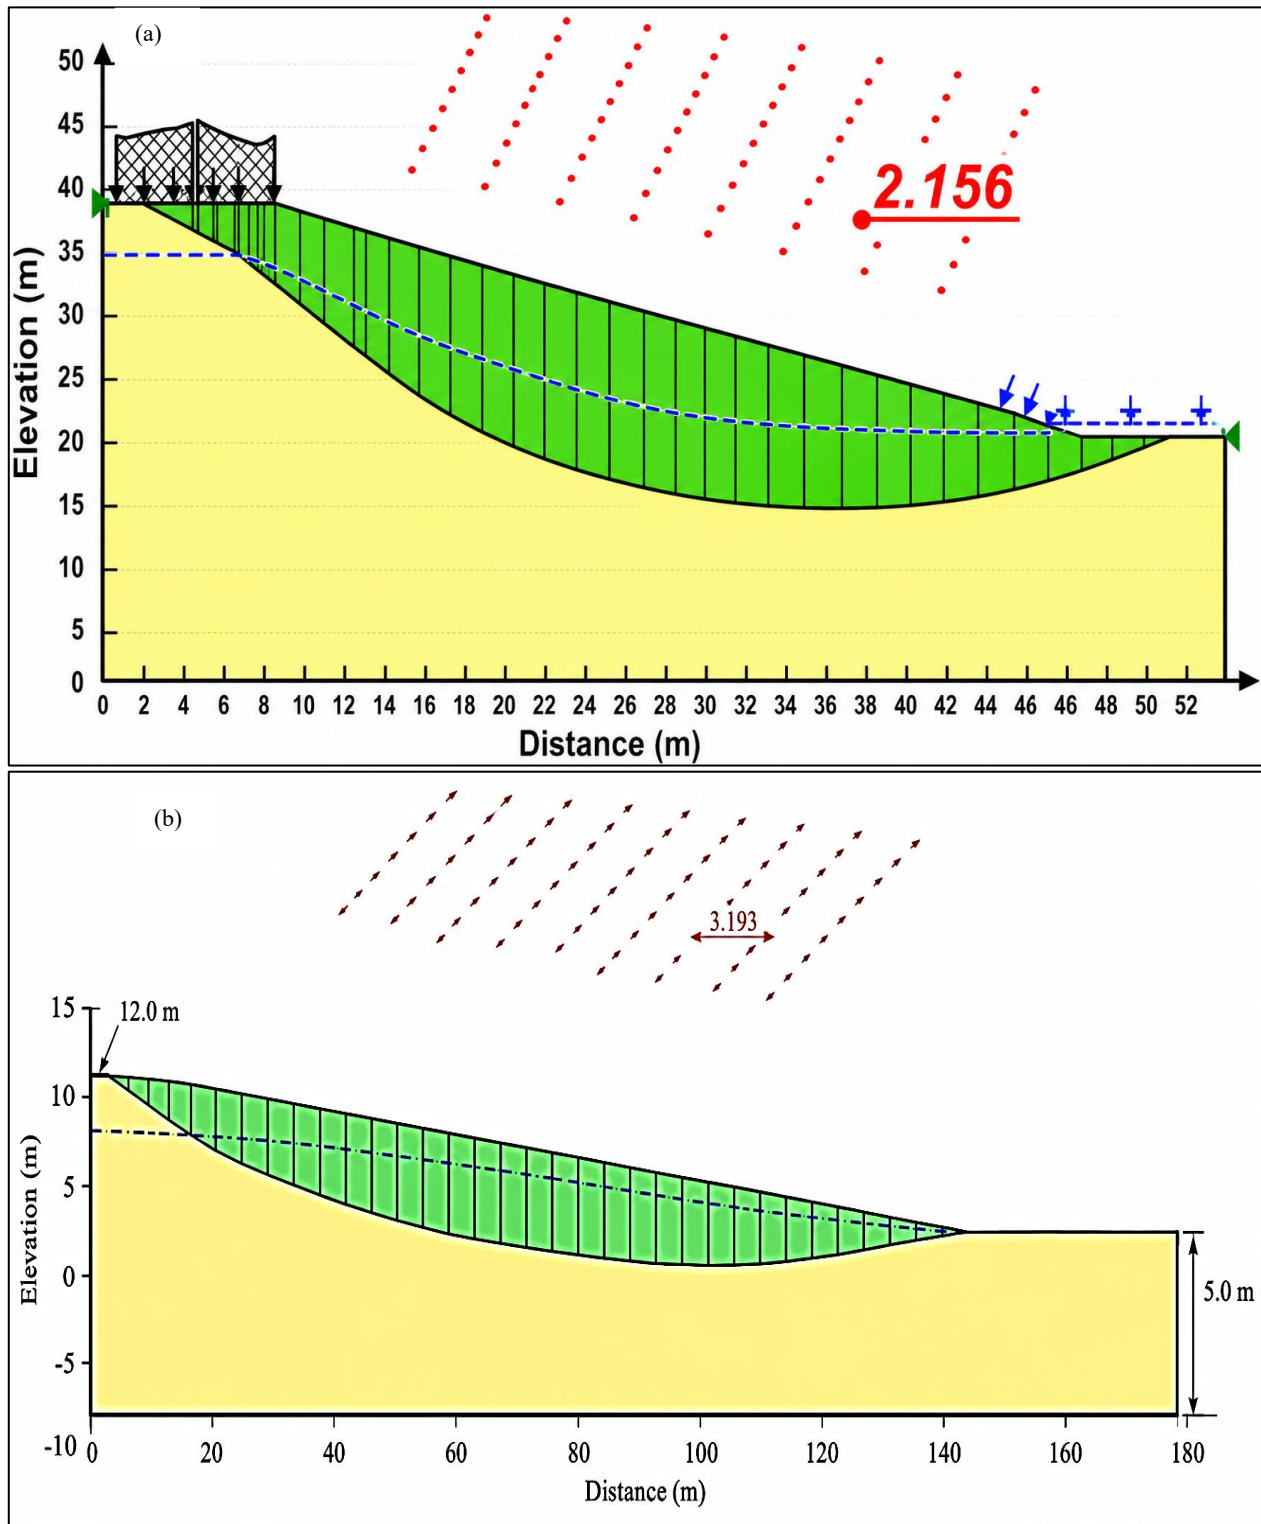
From Table 4, the FoS ranges between 1.86 – 2.16 for the failed sections and 1.79 - 2.93 for the unfailed sections of the downstream slope. The average FoS of the downstream slope are 1.97 and 2.39 for the failed and unfailed sections, respectively.

The computed values therefore indicate satisfactory global slope stability for the analysed conditions (USACE, 2003). Consequently, conventional global rotational slope instability is unlikely to have been the primary mechanism responsible for the observed failure. However, an acceptable global FOS does not preclude localized failure mechanisms. The observed distress may instead be associated with localized seepage, elevated pore-water pressures, inadequate drainage, preferential seepage paths, internal erosion, or spatial variability in embankment materials. These findings are in agreement with that of Duncan et al., (2014).

Figure 6: Sample of FoS for the downstream slope (a) the failed section, (b) the unfailed section
